LOUISIANA DEPARTMENT OF WILDLIFE & FISHERIES

WATERBODY MANAGEMENT PLAN SERIES

KEPLER LAKE

**AQUATIC VEGETATION TYPE MAPS
AND NARRATIVES 1980 - 2018**

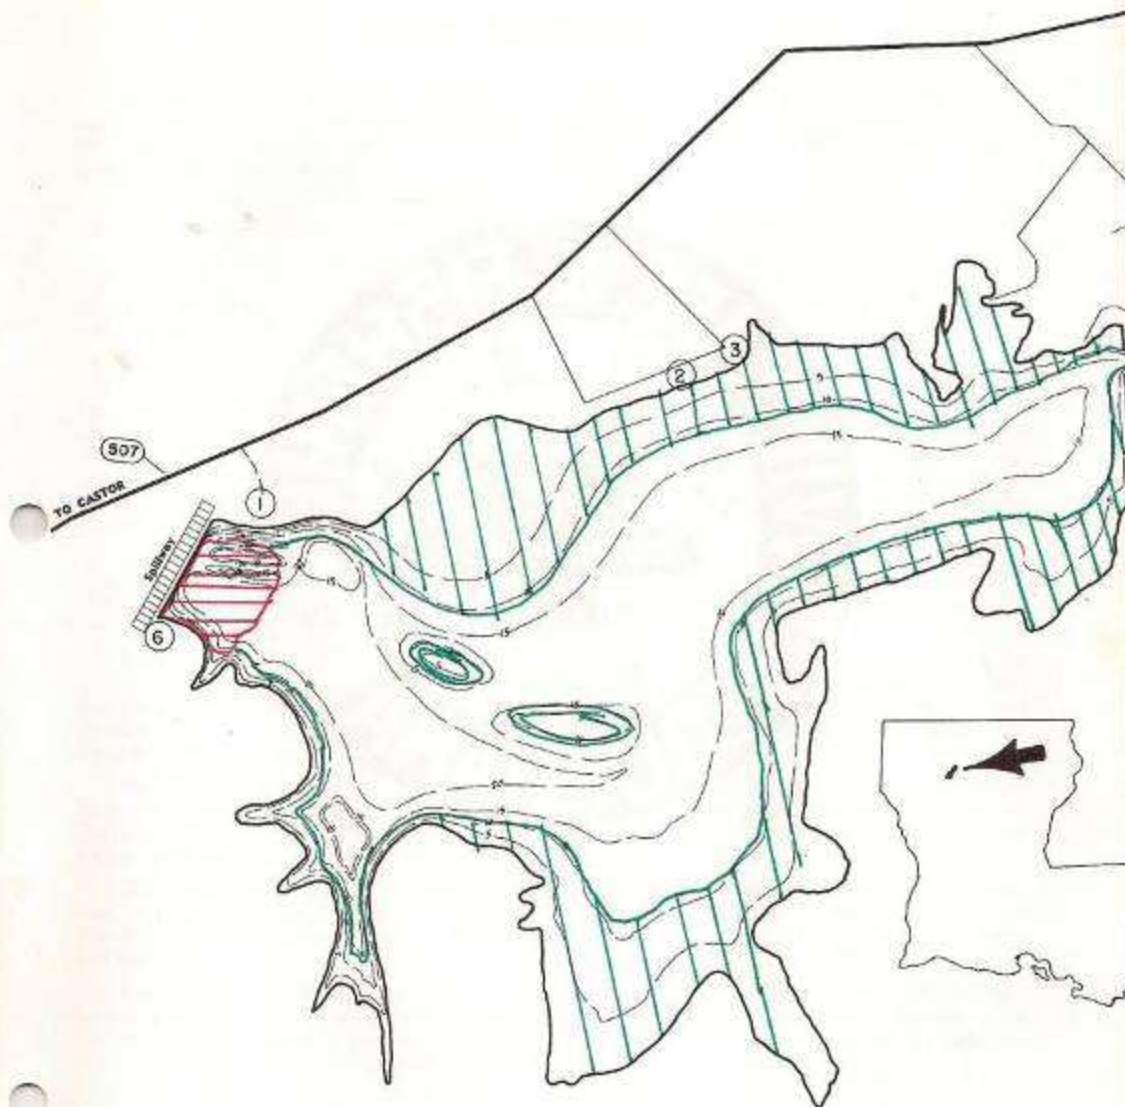
Kepler Lake – Aquatic Vegetation Type Map and Narrative - 1980

Kepler was under a drawdown when the survey was made. The lake was down four feet. The water was clear and no plankton bloom was noticed.

The major submersed plants listed in order of importance are Brazilian elodea (*Egeria densa*), and fanwort (*Cabomba caroliniana*). No other plants were observed during survey. Brazilian elodea (*Egeria densa*) covered an area at the dam and fanwort (*Cabomba caroliniana*) was observed in all other areas.

The major marginal plants were rush (*Juncus spp.*) and American lotus (*Nelumbo lutea*). American lotus (*Nelumbo lutea*) covered about a two acre area in about the middle portion of the lake.

At the time of the survey, Kepler has a severe plant problem.

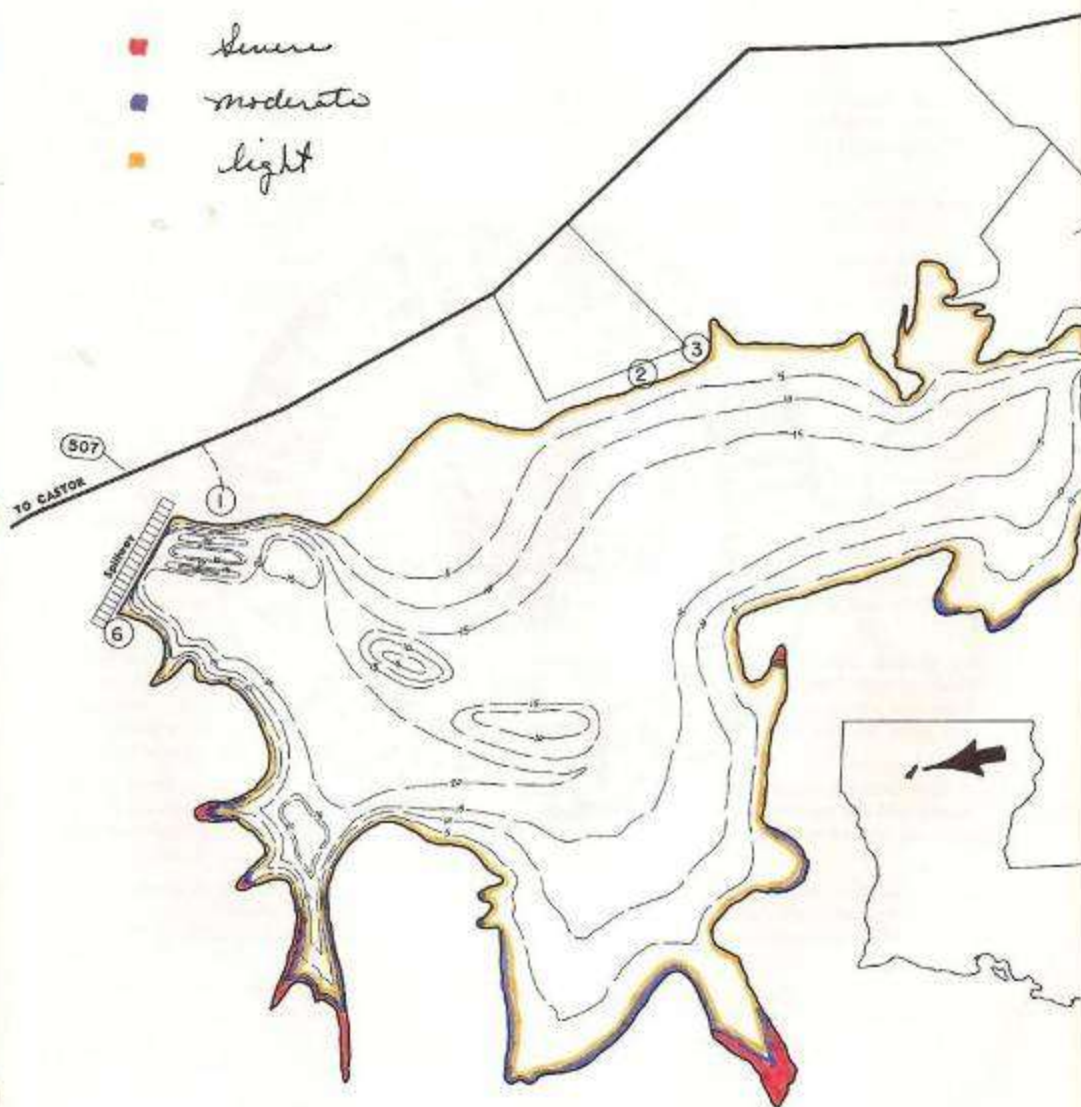
Kepler Lake – Aquatic Vegetation Type Map and Narrative – 1984

At the time of assessment Kepler Lake was at pool stage. There was little plankton bloom noted in any area. Some filamentous algae was noted in almost all areas.

The severe infestations as noted on the type map were comprised of fanwort (*Cabomba caroliniana*), milfoil (*Myriophyllum spp.*), coontail (*Ceratophyllum demersum*), and bladderwort (*Utricularia spp.*). In almost all areas the aforementioned plants were mixed in the infestation.

The moderate infestations consisted of fanwort (*Cabomba caroliniana*), coontail (*Ceratophyllum demersum*), and bladderwort (*Utricularia spp.*).

The marginal plants noted were buttonbush (*Cephalanthus occidentalis*), willow (*Salix spp.*), spikerush (*Eleocharis spp.*), bald cypress (*Taxodium distichum*), cattail (*Typha spp.*), fiddleleaf (*Hydrolea spp.*), water primrose (*Ludwigia octovalvis*), and one spot of alligator-weed (*Alternanthera philoxeroides*).

In summary Kepler Lake is in fair to poor condition. The aquatic plants have increased as anticipated. With the exception of the upper end, all areas of Kepler Lake are accessible to fishermen and boaters.

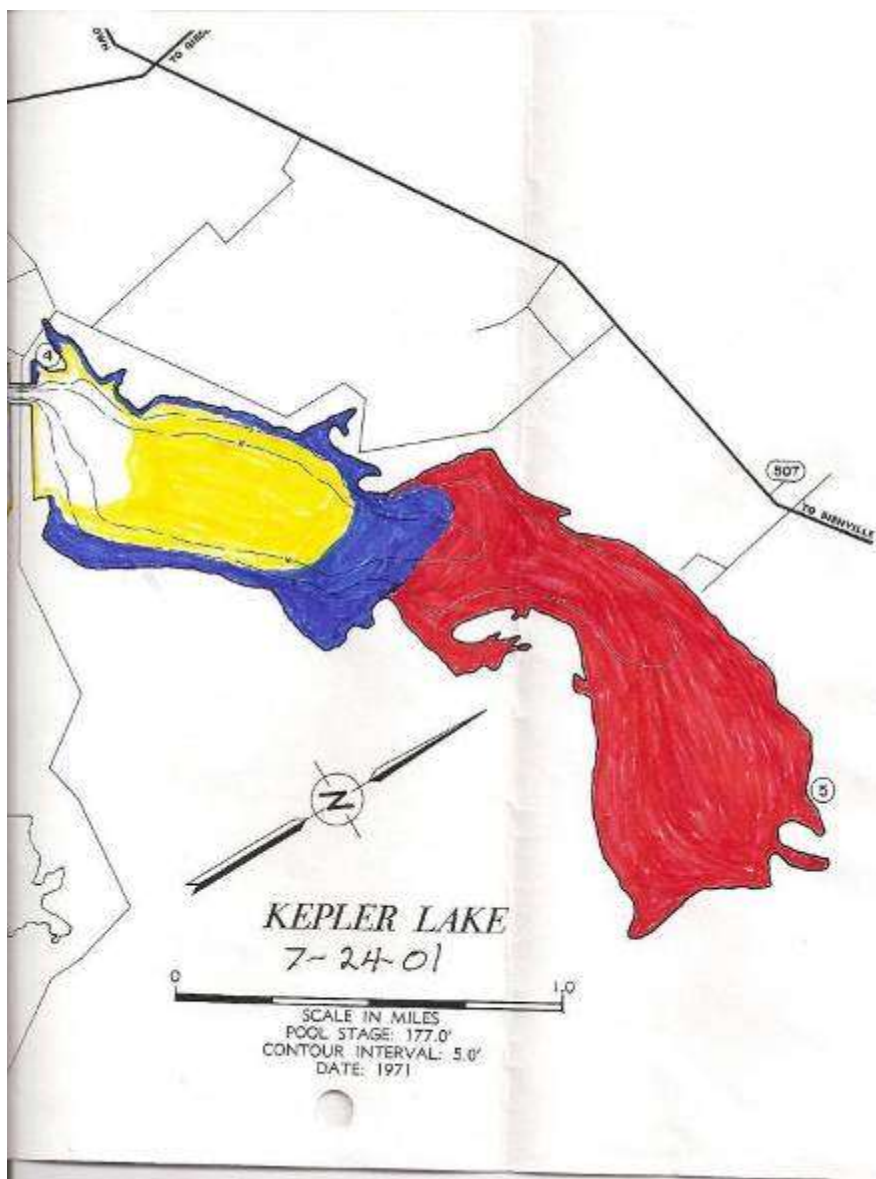
Kepler Lake – Aquatic Vegetation Type Map and Narrative – 2009

A vegetation type map survey was performed in May of 2009. Coverage of submerged aquatic vegetation was approximately 500 acres, and emergent vegetation covered approximately 50 acres. The submerged vegetation consisted of 90% milfoil (*Myriophyllum* spp.), 5% fanwort (*Cabomba caroliniana*), 3% American lotus (*Nelumbo lutea*), and 2% mixture of other species.
